Hastings Water Works

Winter Warm Up

Minimum Service

Brand: Pentair *Model:* MiniMax 400 DV *Serial Number:* 01030179

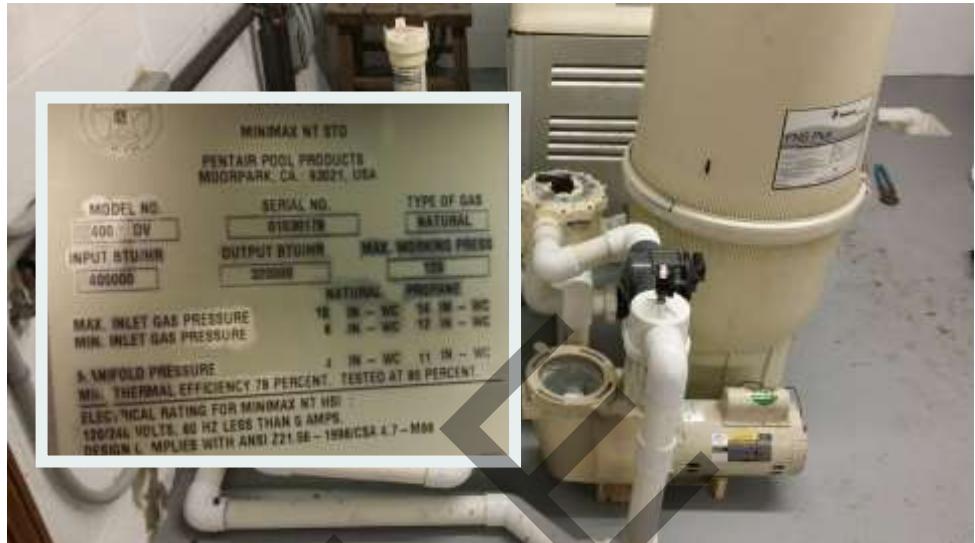
HEAT EXCHANGER W/NEW GASKETS

HEAT EXCHANGER END PLATE

HEATER BURNERS

BYPASS ASSEMBLY

Your heater appears to be over 8 years old. Pentair states the average life expectancy of your heater to be between 5-10 years under normal conditions. Upon further inspection, the heat exchanger bundle appears to be wearing thin where the water flows through the unit.

We did not acid wash the heat exchanger bundle due to it's current clean and soot free condition. We suggest you minimally plan on replacement of the heat exchanger in the upcoming months. Because the heat exchanger bundle is wearing thin, in time, the water will eat through the remaining wall and cause a leak, which can only be fixed with a new heat exchanger. The heat exchanger bundle is \$xxxx (see attached estimate) and we will be happy to schedule replacement if this is your instruction.

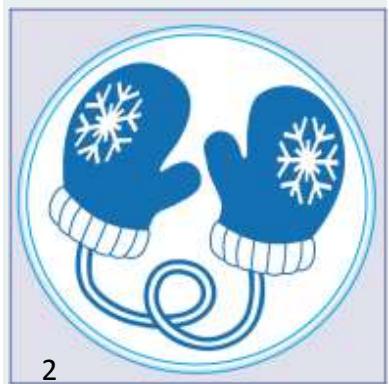
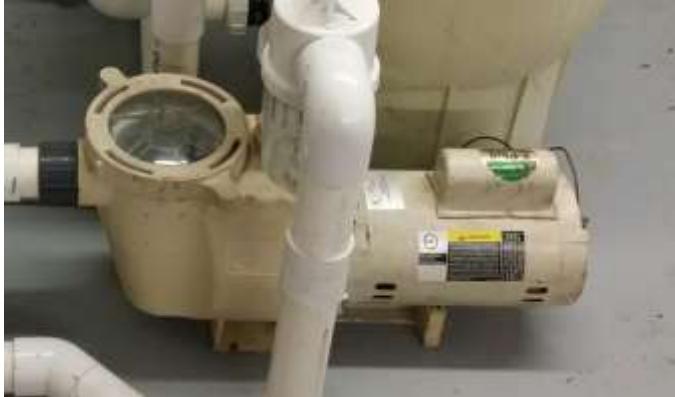
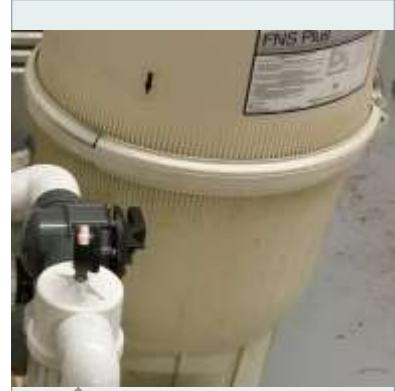
EQUIPMENT INSPECTION

- Inspect Pump-Turn motor on and assess bearing condition
- Inspect exterior of filter tanks for corrosion or damage
- If there is a Chemical Feeder, run to check bearings (Stenner/Blue White)
- Visual inspect all valve handles for defects, replace if needed
- Perform minor repairs, if possible while on premise

Even though we are not electricians, we suggest discussing the installing a 20A GFCI breaker for the pump with a licensed electrician as a best practice.
